YOUR DAMP REPORT

PCA - Damp Survey

Property Period	Georgian (1714-1830)
Property Type	End of Terrace, Lower Ground Flat
Type of Survey	Observational Survey
Occupied / Unoccupied	Occupied and Furnished
Weather During Survey	Dry and Cloudy
Instructions	Clients instruction : Damp appearing in a few rooms in the property, please see photos attached.
Orientation	Please note that all orientation and directional references made in this survey are based on the perspective of facing the front of the building, unless explicitly stated otherwise. For the purposes of this documentation, 'RHS' refers to the right-hand side, and 'LHS' refers to the left-hand side when facing the building from the front. This standard is adopted to maintain consistency and clarity in the description of the property's layout and specific features.

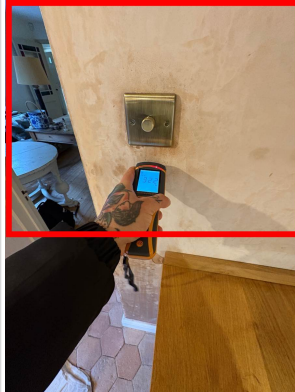
Damp Identified

Electric Moisture Meter	<p>An electrical moisture meter measures moisture content in materials like wood, plaster, and concrete. Essential in construction, woodworking, and water damage restoration, it detects and quantifies moisture levels. The device sends an electrical current between probes touching the material, with moisture affecting conductivity. This alters current flow, allowing the meter to display moisture levels, usually as a percentage or on a scale.</p> <p>This tool is crucial for early detection of dampness or water damage and allows us to detect dampness in the areas identified and reported.</p>
Nitrate Detection Used	No
Chloride Detection Used	No
Types Of Damp Identified	<ul style="list-style-type: none">RisingLateral✓ PenetrativeWoodwormCondensation✓ Defective PlumbingFailed DPC (Damp Proof Course)MouldOther
Defective Plumbing	<p>Professional Detailed Report Statement: During the course of our survey, it was observed that the dishwasher in the kitchen, located directly above the lower ground kitchen, was leaking. This leakage has resulted in damp patches and elevated moisture readings on the ceiling of the lower ground kitchen. The client is aware of this issue and has arranged for a plumber to attend and address the matter later on the same day as our survey.</p>

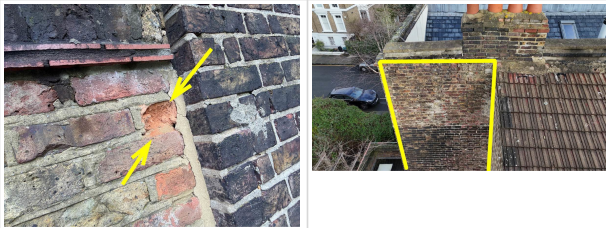
The external wall itself has missing mortar joints and spalled bricks. Approximately 30m² of pointing has deteriorated and 15 spalled bricks, creating gaps that allow moisture to penetrate the structure. Additionally, the chimney stack was found to have extensive defects, including missing flaunching and large areas of missing or perished pointing.

Spalled Bricks : Numbers Of Bricks	15	
Spalled Brick Images

and replaced with a lime-based mortar. Lime-based mortar is highly breathable and flexible, allowing trapped moisture to escape while preventing further water ingress. All deteriorated and perished bricks, around 15 in total, must also be replaced with bricks of matching type and size to restore the structural integrity of the wall.

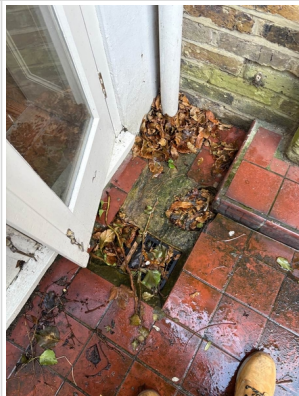
<p>Trap jumper required couldn't locate manhole</p>

<p>Trap jumper required couldn't locate manhole</p>
CLIENT INSTRUCTION	Book our in-house Drainage Team as soon as possible to prevent further issues.

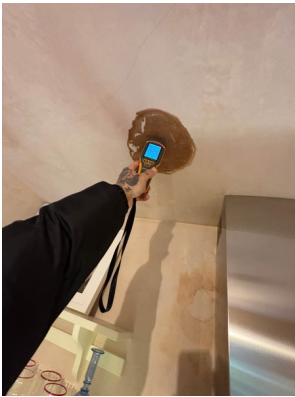
<p>Elevated moisture reading obtained</p>

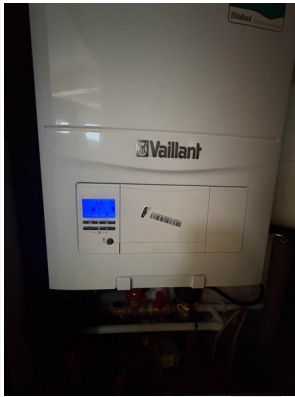
<p>Boiler pressure satisfactory</p>

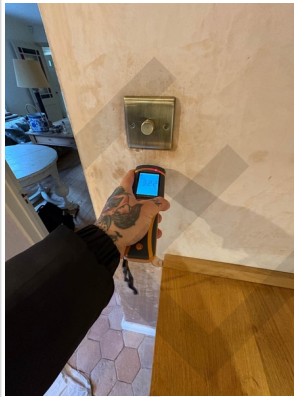
<p>Elevated moisture reading obtained</p>

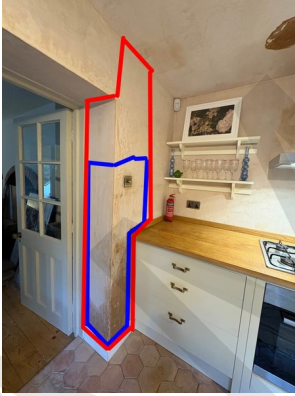
<p>Blue = elevated moisture readings obtained</p> <p>Red = damp works required</p>

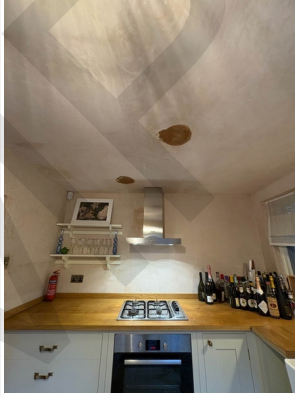
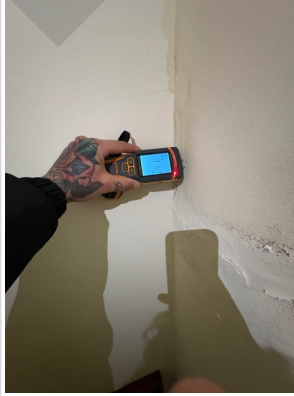
<p>Elevated moisture reading obtained</p>

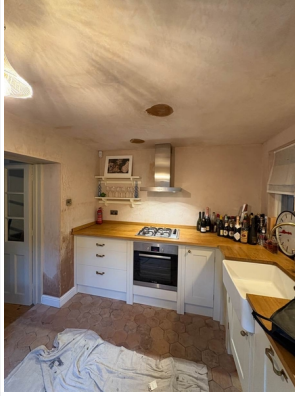
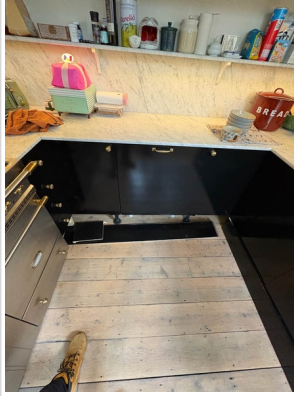
During our survey, elevated moisture levels were recorded in the ceiling of the lower ground floor kitchen, with readings ranging from 40% to 45%. Visual inspection confirmed damp staining in two specific areas of the ceiling. An investigation into the room directly above, which is another kitchen, revealed that a dishwasher located beneath the plinth was leaking. This leak has been the primary source of the moisture affecting the lower ground floor ceiling. The client was made aware of this issue and confirmed that a plumber had been arranged to repair the dishwasher later that day.

<p>Leak detected from the dishwasher beneath the plinth in the kitchen above.</p>

It is advised that once the repair is completed, a drying period of six weeks is allowed for the ceiling to thoroughly dry. After this period, the ceiling should be reassessed to determine if additional internal works, such as plaster replacement, re-skimming, or redecoration, are required. Particular attention should be given to assessing whether any underlying damage to the ceiling structure has occurred, as this may necessitate repair or replacement of affected sections.

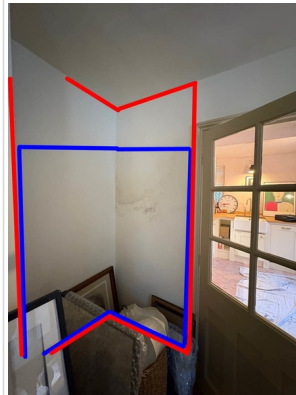
Leak detected from the dishwasher beneath the plinth in the kitchen above.

Blue = elevated moisture readings obtained

Red = damp works required

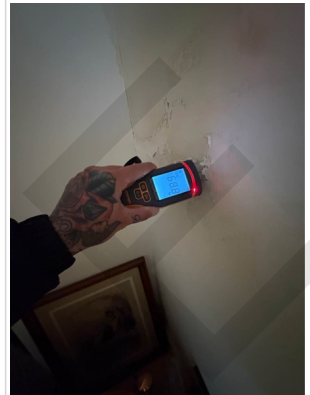
Elevated moisture reading obtained

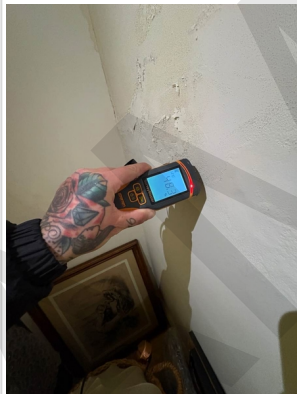
Elevated moisture reading obtained

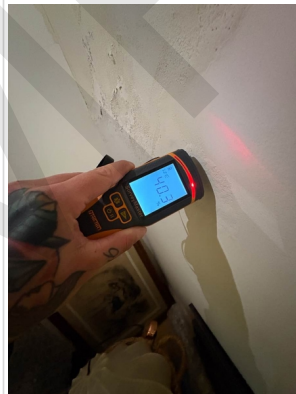
Elevated moisture reading obtained

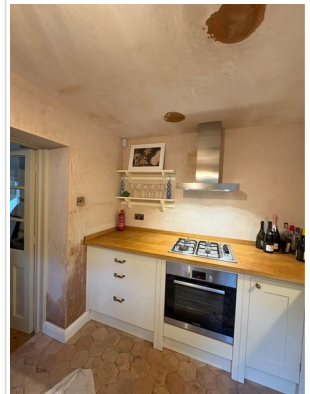
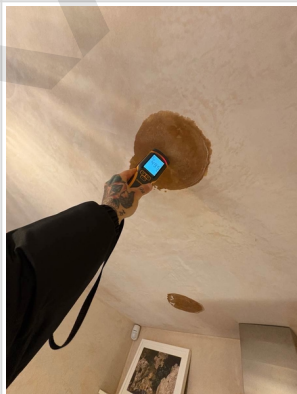
Elevated moisture reading obtained

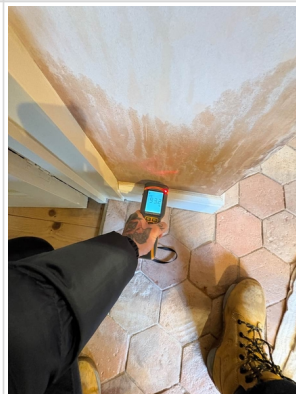
Elevated moisture reading obtained

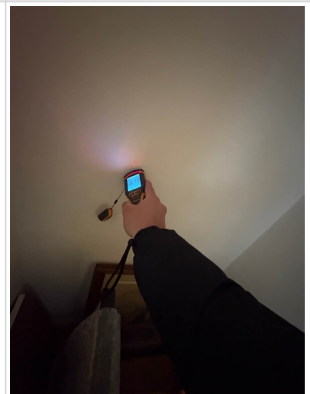
Elevated moisture reading obtained
