YOUR DAMP REPORT

PCA - Damp Survey

Property Period	Georgian (1714-1830)
Property Type	End of Terrace, Lower Ground Flat
Type of Survey	Observational Survey
Occupied / Unoccupied	Occupied and Furnished
Weather During Survey	Dry and Cloudy
Instructions	Clients instruction : Damp appearing in a few rooms in the property, please see photos attached.
Orientation	Please note that all orientation and directional references made in this survey are based on the perspective of facing the front of the building, unless explicitly stated otherwise. For the purposes of this documentation, 'RHS' refers to the right-hand side, and 'LHS' refers to the left-hand side when facing the building from the front. This standard is adopted to maintain consistency and clarity in the description of the property's layout and specific features.

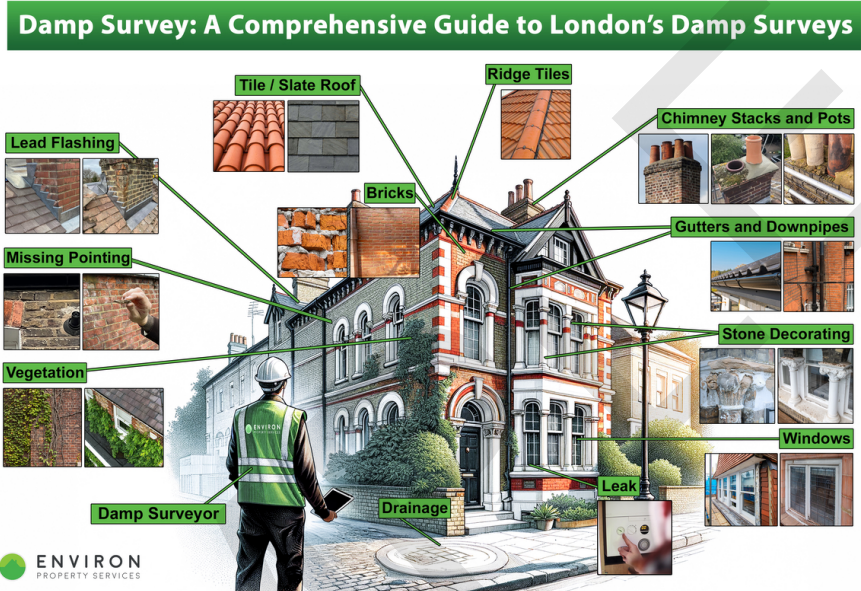
Localised External Defects	Yes	
Stop the Water Ingress	<p>We have highlighted the below external defects. It is very important to follow our recommendations as these defects will worsen in bad weather conditions. The Property/Building must remain water tight at all times to prevent further dampness. Such water ingress causes structural damage which can severely decrease a value and market appeal when going to sell, remortgage or rent. The causes of Dampness must be tackled head-on.</p>	
Spalled Bricks	Yes	
Spalled Bricks:	<p>Spalled bricks with surface deterioration allow water to infiltrate the building's exterior. This water ingress, especially during rain or wet conditions, will result in dampness problems within the walls. Recommendation: Cut out defective bricks/ poor mortar repairs from face of wall, clean and clear away, supply and lay reclaimed bricks to match existing in a lime mortar (1:2:9), bond, bed and point using approved mix / to match existing or reface the bricks to match the sounding bricks.</p>

Spalled Bricks : Numbers Of Bricks	15	
Spalled Brick Images

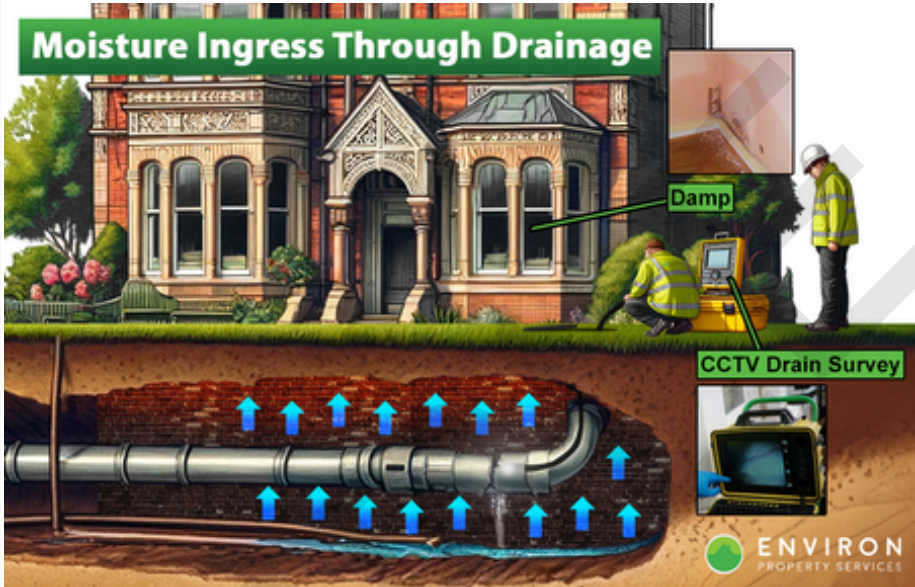
Underground Drainage Survey	Yes	
Underground Drainage Survey:	<p>Underground Drainage Survey To effectively address the dampness in your property, a comprehensive drainage survey is essential. This involves a detailed inspection of the underground drainage system using advanced CCTV technology. Initially, we undertake high-pressure jetting to clear any blockages, ensuring an unobstructed pathway for the CCTV equipment. This preparatory step is vital for a thorough and effective survey.</p> <p>Once the drainage system is clear, our expert surveyors deploy CCTV cameras to meticulously examine the underground pipes. This process allows us to identify any structural issues, such as fractures, blockages, or misalignments, that could be contributing to the damp problem. A full written report with supporting images will be provided by one of our inhouse NADC Drainage Engineers</p> <p>By identifying the root cause of the dampness through this advanced survey, we can recommend targeted remedial actions to resolve any issues. This approach ensures a comprehensive solution to the dampness, safeguarding the long-term integrity of your property.</p>
